Corrosion

Official Publication
NATIONAL ASSOCIATION OF CORROSION ENGINEERS

Vol. 14

MAY, 1958

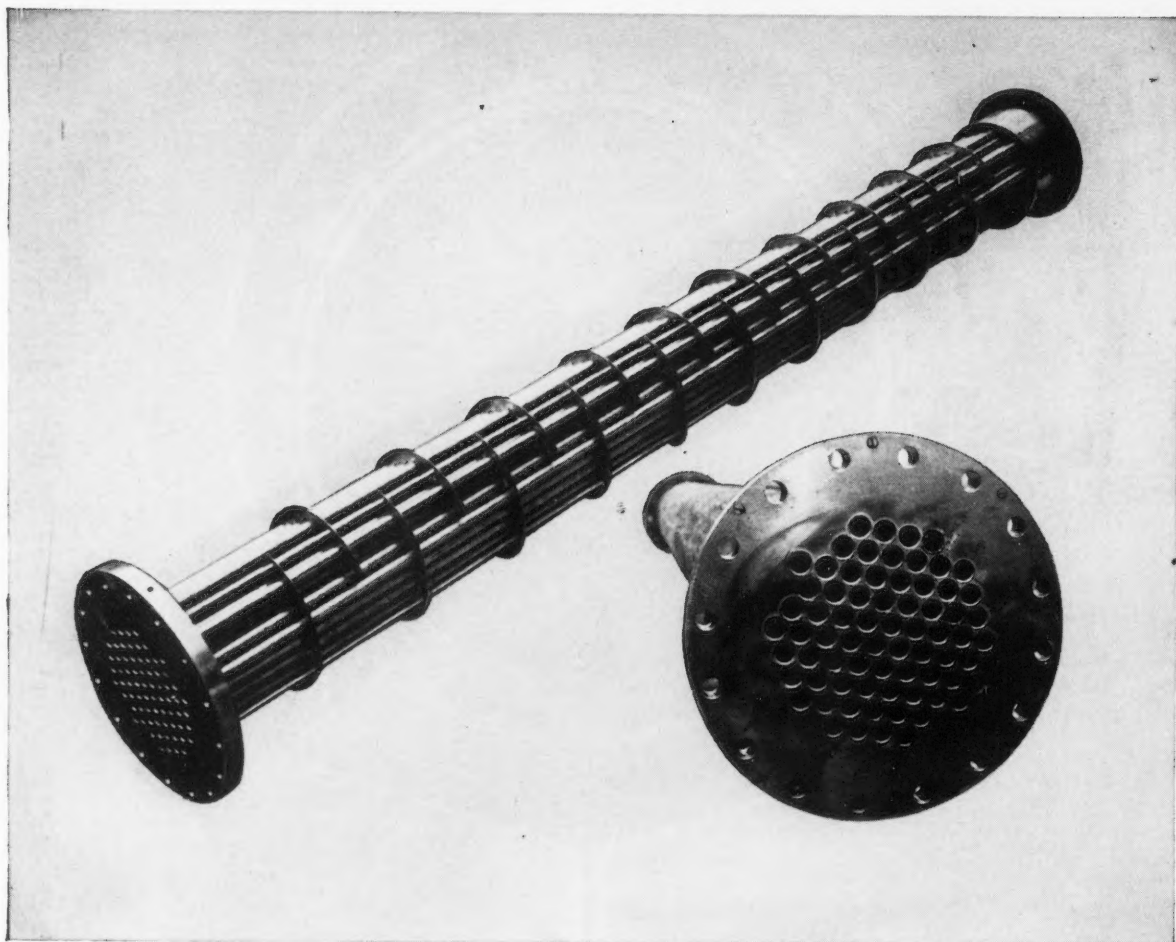
• The life of this titanium 70-tube condenser assembly, now handling 60% nitric acid at 195° C. and 180 psi, is estimated to exceed 10 years.

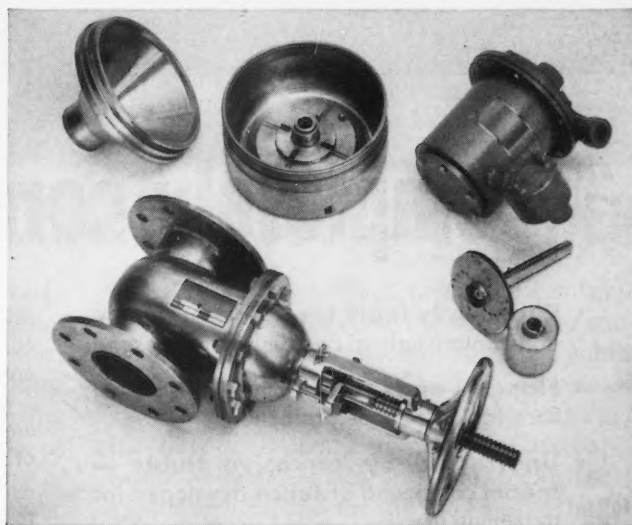
NOW AVAILABLE, titanium parts and fittings like this 4" gate valve, chemical pump and centrifuge can be made to your order by process-equipment fabricators.

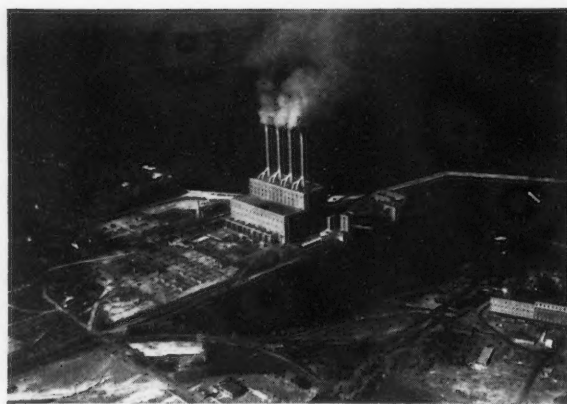
Figure 1—Aerial photograph of Niagara Mohawk Power Corporation's Oswego (New York) Steam Station.

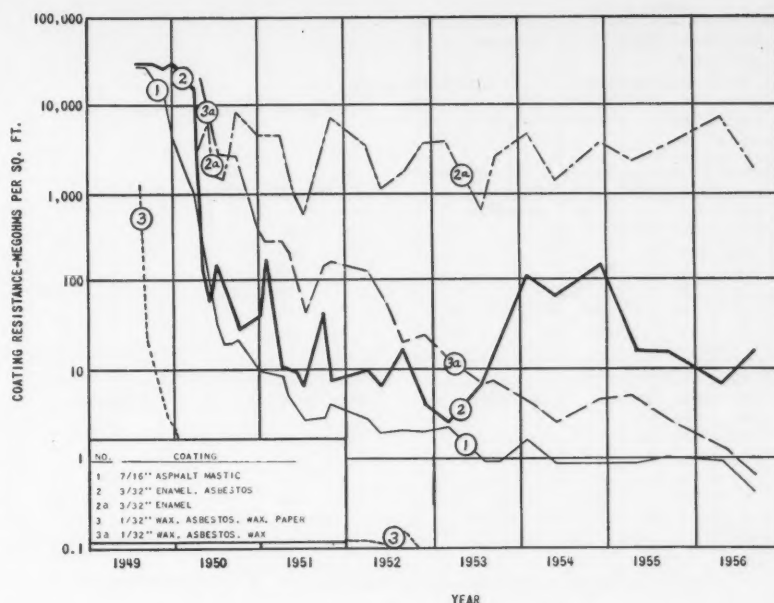
Figure 7—Insulation resistance of pipe coatings in soil boxes (median values plotted).

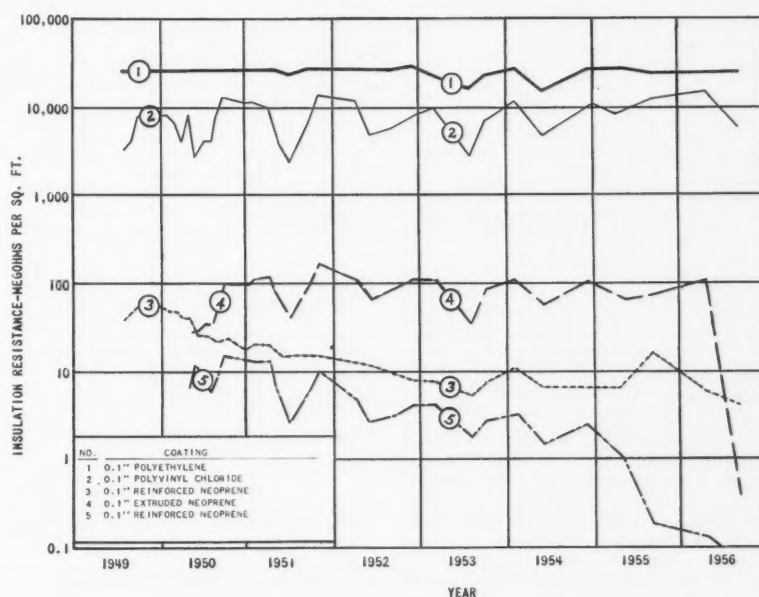
Figure 8—Insulation resistance of cable coatings in soil boxes (median values plotted).

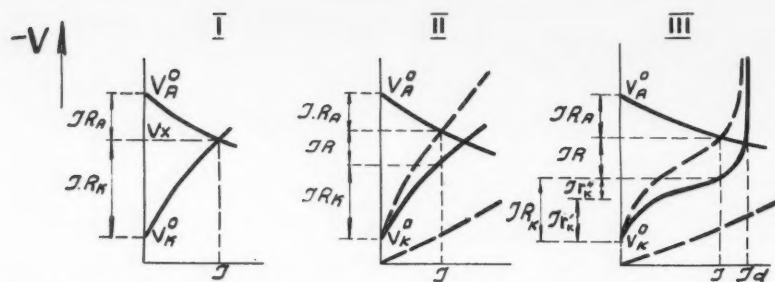
Figure 1—Determination of corrosion control nature from analysis of polarizing diagrams. I—Ohmic resistance is low, relationship $R_A:R_K$ determined from relationship $IR_A:IR_K$. II—General case. Relationship $R_A:R_K$ determined from relationship $IR_A:IR_K$. III—more detailed characteristic of cathode control. Relationship $R_A:r'_k:r''_k:R$ determined from relationship $IR_A:IR_K:IR$ taking into account the equations

where r'_k —is the inhibition caused by the cathode reaction; r''_k —the inhibition caused by depolarizer diffusion; I —corrosion current; I_d —maximum diffusion current. (For detailed calculation see Reference 33).

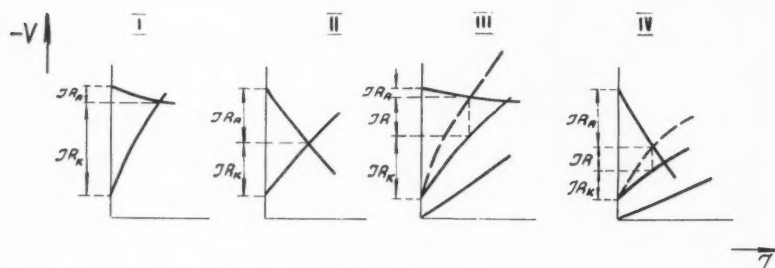
Figure 2—Typical cases of corrosion control for different conditions of corrosion: I—active corrosion in electrolytes; II—corrosion in passive state; III—corrosion at the expense of macrocouple (soil corrosion); IV—corrosion under a thin film of moisture (atmospheric corrosion).

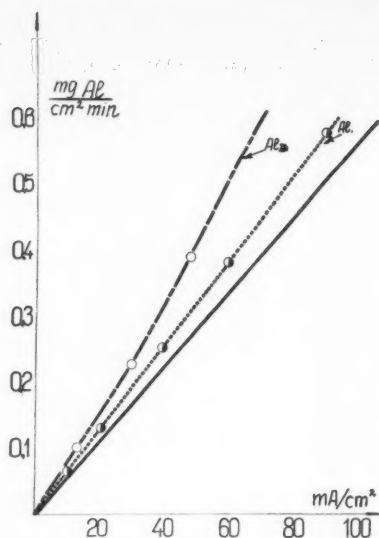
Figure 5—Dissolution rate of aluminum (Al) and Duralumin (Aln) at anodic polarization in a 0.5N NaCl solution.⁽²³⁾

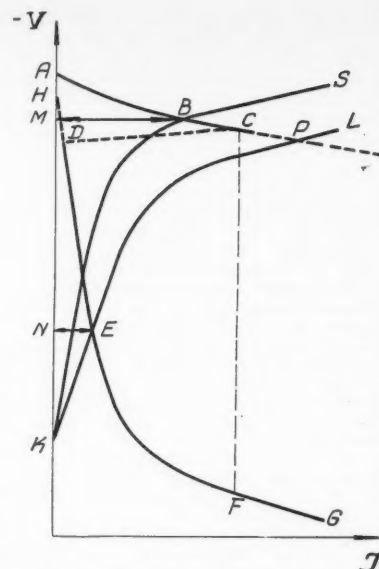
Figure 9—Corrosion diagram illustrating the possibility of facilitating passivation as a result of cathodic alloying.

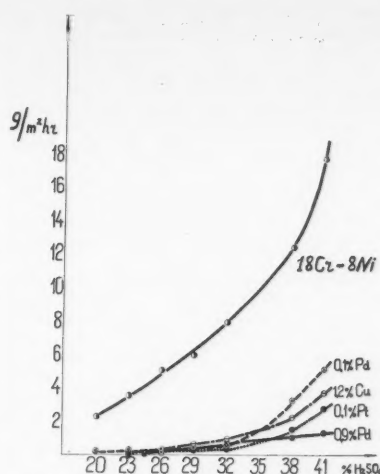
Figure 10—Corrosion rate of chromium-nickel stainless steels (18 percent Cr and 8 percent Ni) alloyed with cathodic additions (Pt, Pd, Cu) depending on H_2SO_4 concentration. Trial length—360 hours, temperature 20C.

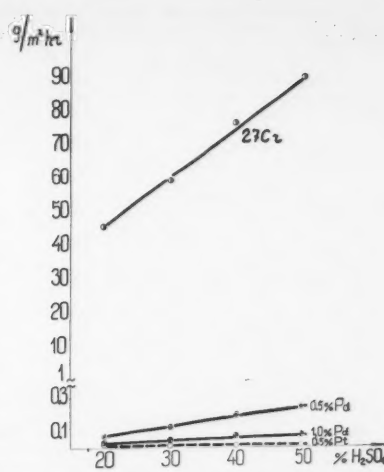
Figure 11—Corrosion rate in H_2SO_4 of chromium steels with 27 percent Cr alloyed with cathodic inclusions (Pt or Pd). Duration of test was 100 hours, temperature was 20C.

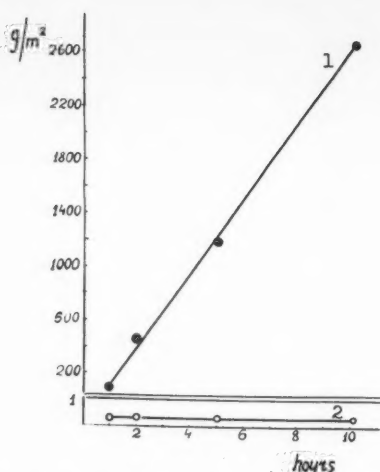
Figure 12—Effect of anodic polarization on corrosion of 18-8 steel in 50 percent H_2SO_4 at 50°C. Line 1 is for steel corrosion without anodic polarization; Line 2 is for steel corrosion at anodic polarization with current density $2.5 \mu A/cm^2$.

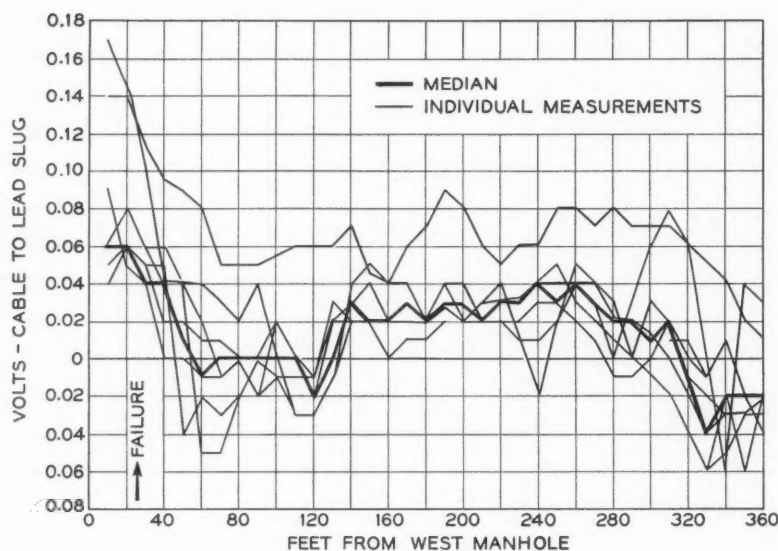
Figure 11—Duct surveys in multiple duct subway.

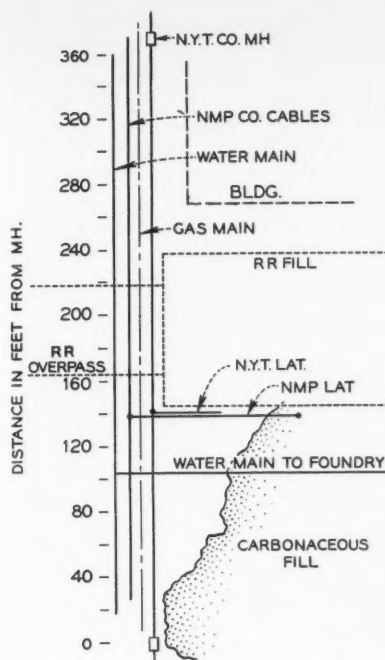
Figure 16—Plan view of area surrounding manhole section.

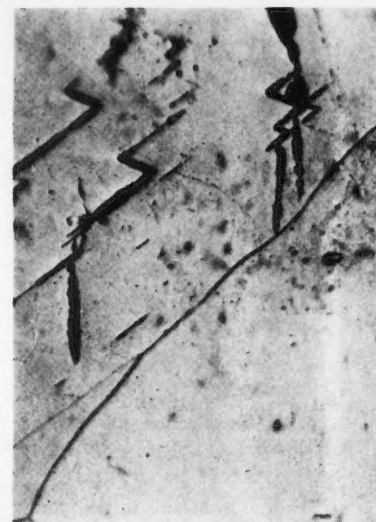
Figure 6—Same specimen as pictured in Figure 5 but after a one-hour exposure to boiling $MgCl_2$ solution. Cracks formed. Original magnification, 600X; actual magnification after reduction for engraving purposes, 440X.

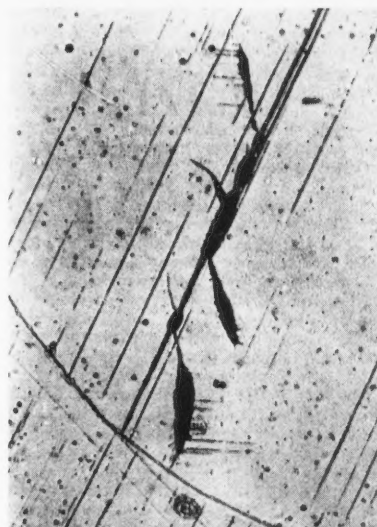
Figure 8—Slip along pits formed at the tips of cracks. Original magnification, 550X; actual magnification after reduction for engraving purposes, 305X.

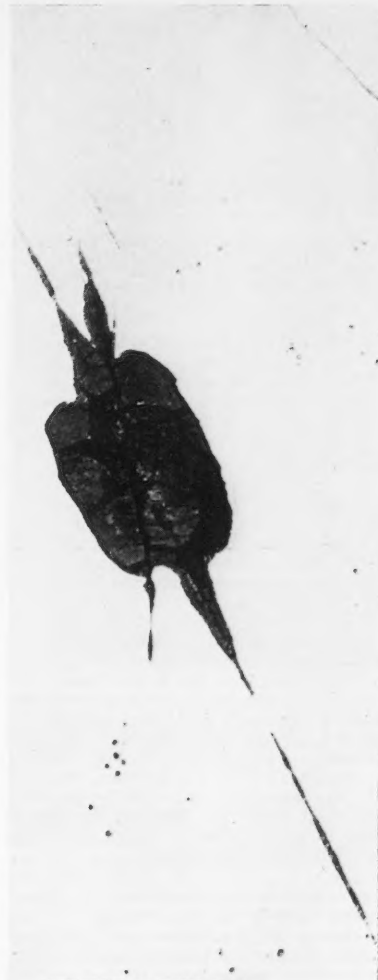
Figure 9—Fine structure of a pit. Original magnification, 450X; actual magnifications after reproduction for engraving purposes, 600X.

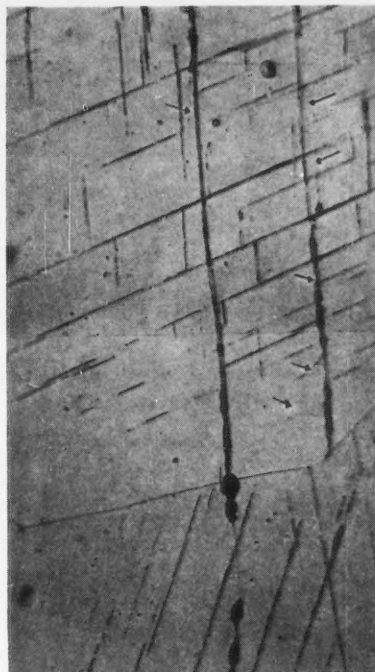
Figure 14—Heavily stressed material. Note attack at the slip bands and cracks formed. Arrows point to crack. Original magnification, 900X; actual magnification after reduction for engraving purposes, 540X.

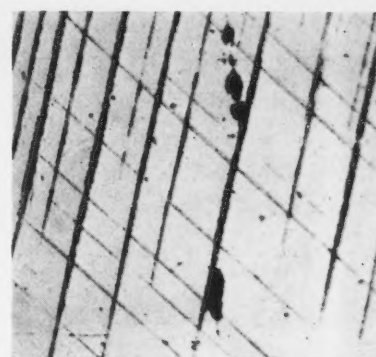
Figure 15—Steel A deformed at 200 C. Note attack at the slip bands and crack formed. Original magnification, 540X; actual magnification after reduction for engraving purposes, 440X.

stressing showed no α -ferrite. Steel A (AISI 304) was stressed at 200 C (deflection: 4 mm) and then immediately exposed to boiling $MgCl_2$ solution. It may be assumed that at this temperature no α -ferrite (martensite) is formed. The slip bands formed were very numerous owing to the drop in the yield point. The same attack was observed as when deforming this austenitic steel at room temperature (Figure 15).

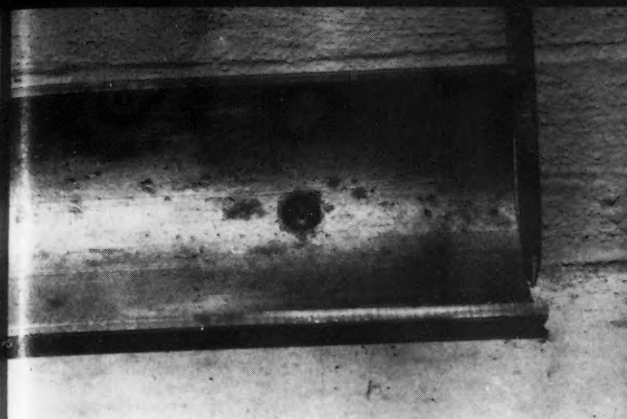
Figure 1—Penetration of new 3/16-inch thick injection string, after 3.5 month exposure. Hydrogen sulfide content of water was 105 mg/liter; temperature was 115 F.

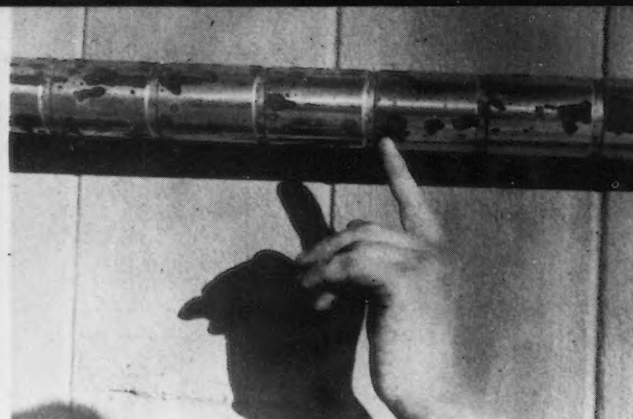
Figure 2—Metal-to-metal chrome plated plunger in service 35 days. Hydrogen sulfide content of water was 1.0 mg/liter coupled with CaCO_3 deposition.

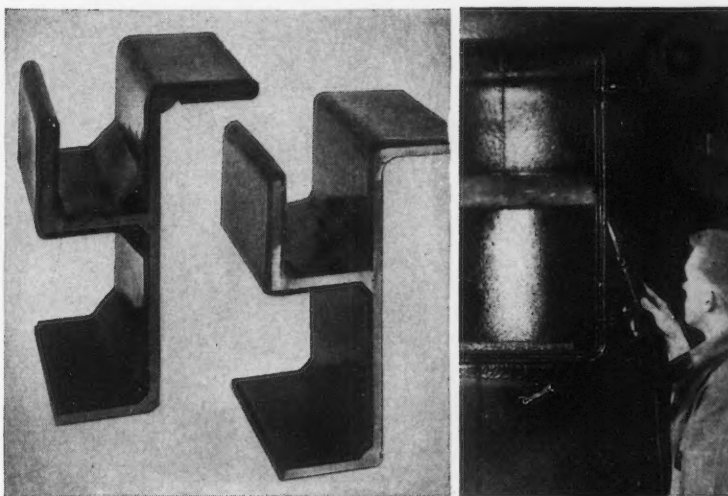
Section at left shows how sheet linings are applied, with seams at all sharp bends. Contrast this with the continuous, seamless "Super 5300" lining on section at right. There are no weak spots where solutions could undercut lining. (Far right): Spark testing of fume scrubber shown reveals no porosity in the protective "Super 5300" lining.
